**PROPOSAL FOR ADMINISTRATIVE
NO FURTHER ACTION
ENVIRONMENTAL RESTORATION
SITE 88A, FIRING SITE: RANCH HOUSE
OPERABLE UNIT 1334**

August 1994

Prepared by
Sandia National Laboratories/New Mexico
Environmental Restoration Project
Albuquerque, New Mexico

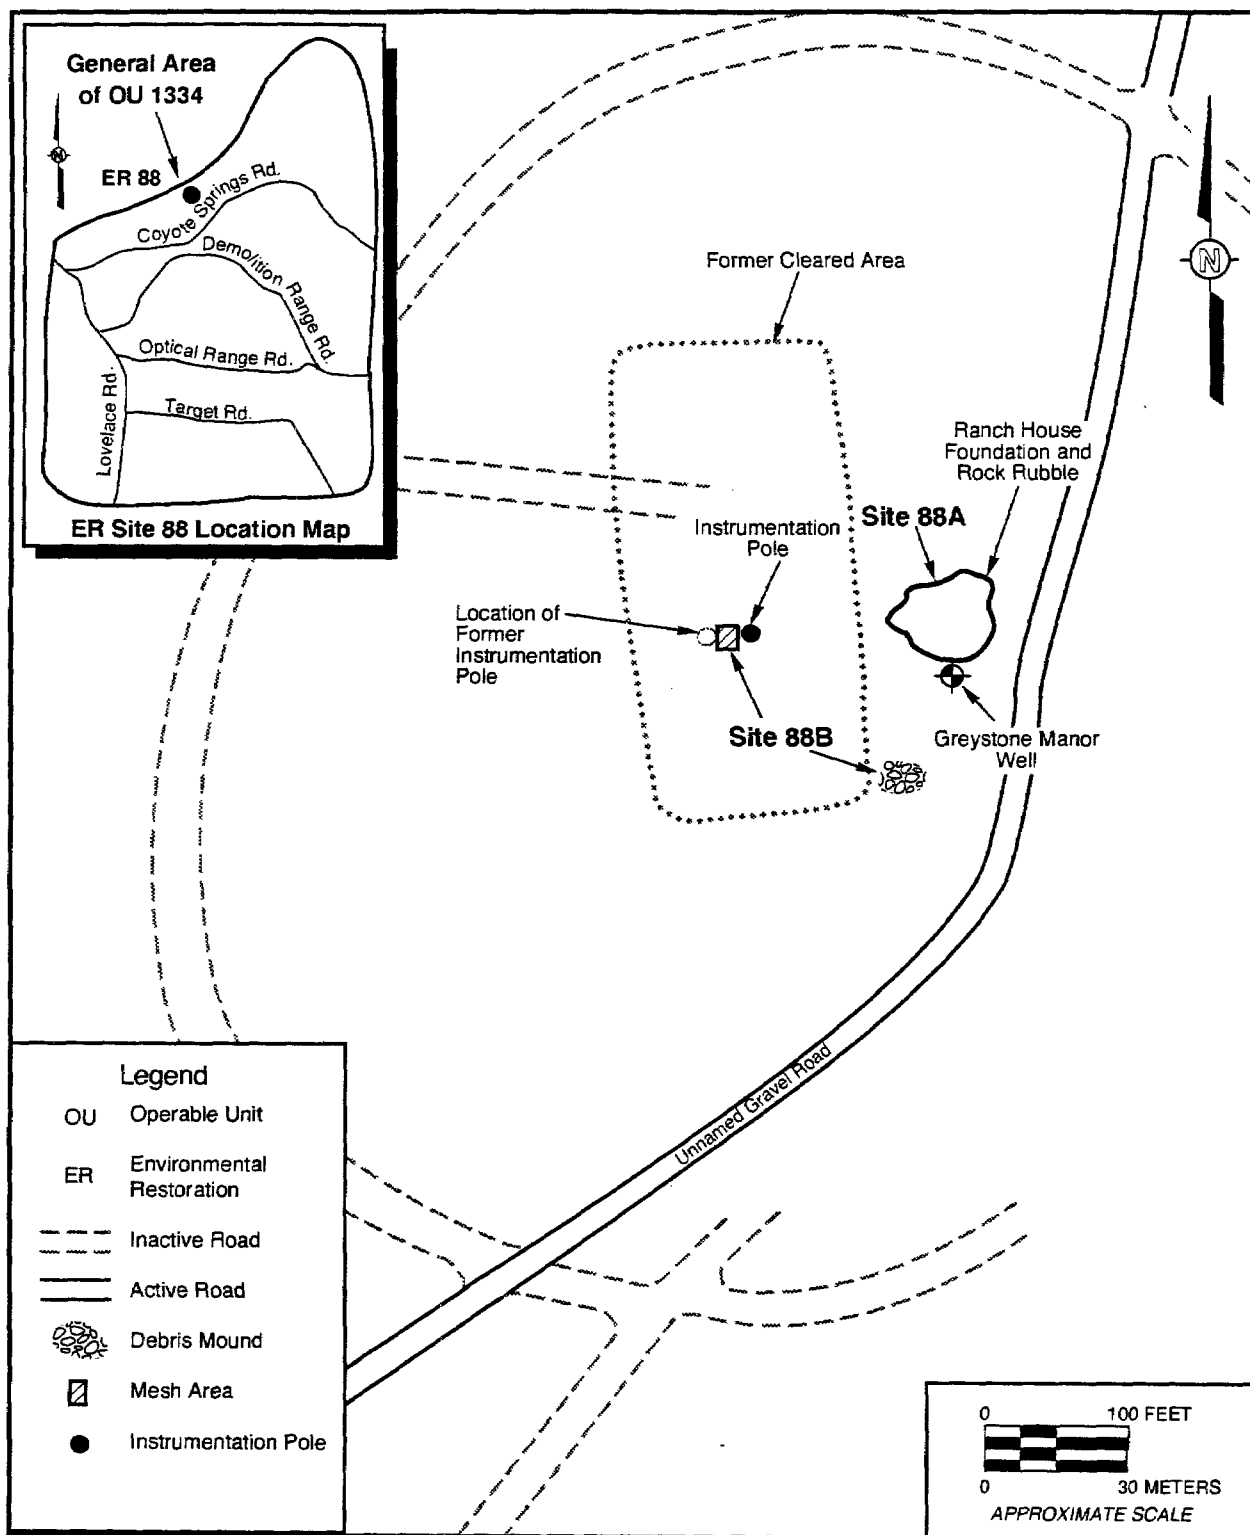
Figure 2-2
Site Map of ER Site 88, Firing Site: Ranch House (88A) and
Instrumentation Poles (88B)

ER Site 88A (Figure 2-1) consists of the foundation and rubble from a former Ranch House building (Figure 2-2) and the Greystone Manor well, which is routinely monitored by the SNL/NM Sitewide Hydrogeologic Characterization Project at the site (88-17).

The concrete foundation of the former Ranch House is surrounded by cobble-sized rocks from which the structure was constructed. Pieces of wood believed to have been part of the building are found among the rocks. A 2-ft-deep wood-lined pit is located within the foundation and rubble area. According to interviews with former SNL/NM employees, this pitched-roof Ranch House consisted of two rooms with walls of field stone and mortar (62-29). In a 1963 SNL/NM drawing, this structure was referred to as the "Hacienda" and had the building number 9855 (88-22).

The Greystone Manor well is located approximately 10 ft south of the former Ranch House and consists of a 7-in.-diameter steel standpipe that rises out of a 4-ft by 6-ft concrete slab. The height of the pipe is approximately 2 ft (88-17), and it is covered with a locked cap. This monitoring well is designated as the Greystone Manor well because the ranch house was previously thought to have been the remains of Greystone Manor. It is now known that Greystone Manor was located near Coyote Springs. Adjacent to this well, a 10-in.-diameter

rusted metal standpipe rises out of the ground surface. A large piece of weathered wood rests on the top of and covers the pipe. This pipe protects a valve box that was probably used for the former Ranch House water system (88-17).
